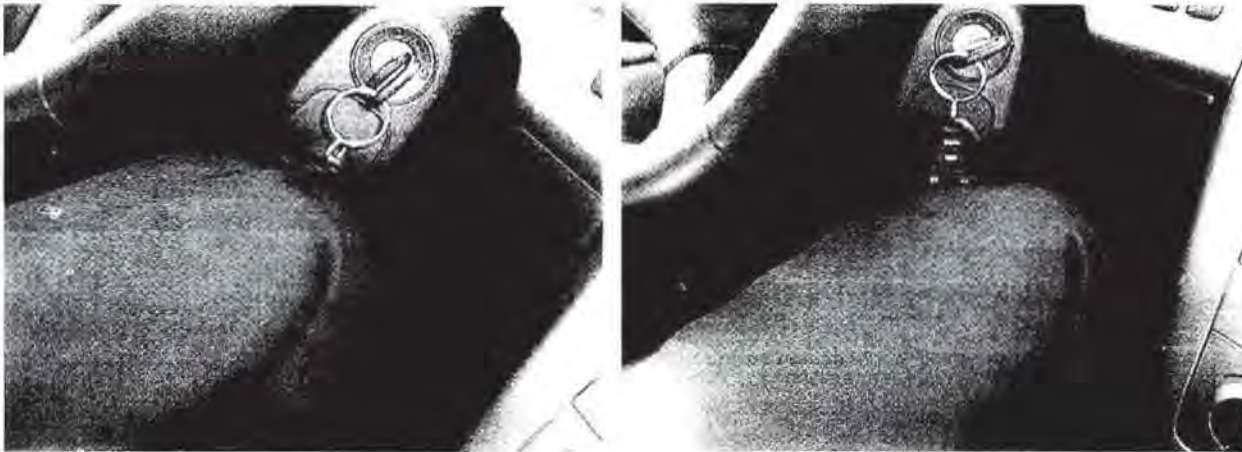
65. The photographs below depict a GM engineer in the driver's seat of a Cobalt during the investigation of Cobalt stalling incidents. Note the proximity of the driver's knee to the ignition key:

66. These photographs show the dangerous position of the key in the lock module on the steering column, as well as the key with the slotted head, which allows the key fob to hang too low off the steering column. GM engineers understood that the key fob can be impacted and pinched between the driver's knee and the steering column, and that this may cause the key to inadvertently turn from the "run" to the "accessory" or "off" position. The photographs show why GM engineers understood that increasing the detent in the ignition switch would not be a total solution to the problem, for such a step would not alleviate the possibility of impacting the key with a driver's knee. The photographs also show why GM engineers believed that additional changes (such as the shroud) were necessary to fully fix the defects with the ignition switch.
